BLM-Alaska Open File Report 64  
BLM/AK/ST-97/022+8111+040  
April 1997

# HISTORIC BUILDING SURVEY REPORT FLAT, ALASKA

by Rolfe G. Buzzell and Darrel L. Lewis

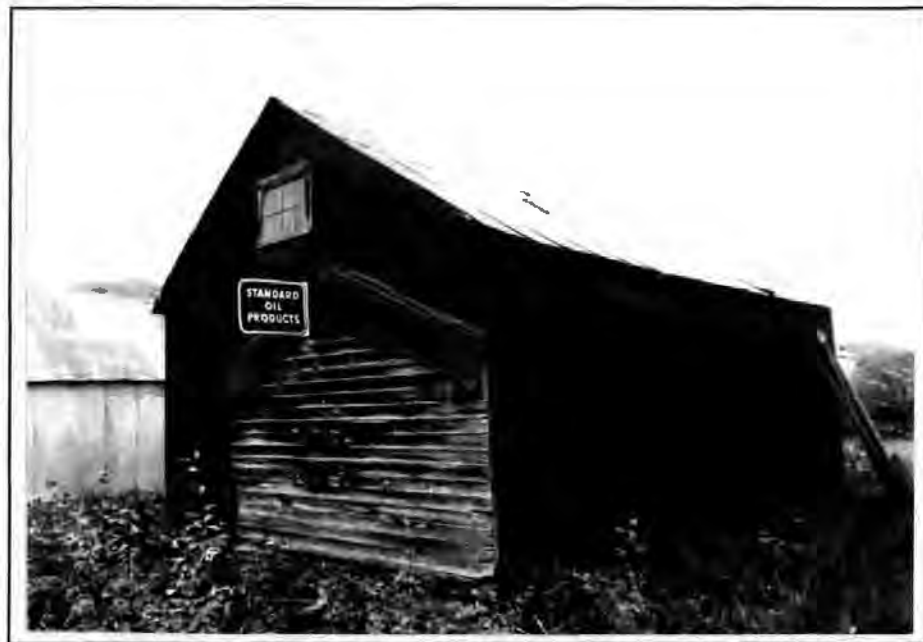
The **Donnelley/Standard Oil Warehouse (IDT-084)** is a rectangular, 1.5 story, wood frame building (Figure 42) measuring 20'x30'. The foundation consists of logs on grade. The gable roof and exterior walls are covered with corrugated metal. The west elevation has a six-light, fixed sash window centered in the gable and a "Standard Oil" sign on the upper part of the building. A six-light, fixed sash window located in the east gable and a door covered by corrugated metal is located at the south end of the of the east elevation.

**Figure 42. The Donnelley/Standard Oil Warehouse, 1993. The view is looking northeast.**

The date and location where the oil warehouse was built are unknown. The warehouse may have been built in Iditarod and moved to Flat. Harry Donnelley was the distributor for Standard Oil Company products in Flat. He stored petroleum products in the warehouse in the late 1920s and 1930s after it was moved to Flat. In about 1930, the building was turned so that its gable ran north-south. When the building was rotated to its present east-west orientation is unknown. Prior to 1930, the building had a gable roof addition. The outline of that addition, which faced south prior to 1930, is still visible on the west side of the building. In 1993, a power plant that generated electricity for the Donnelley House was located in the Donnelley/Standard Oil Warehouse (Miscovich 1995:III-41).

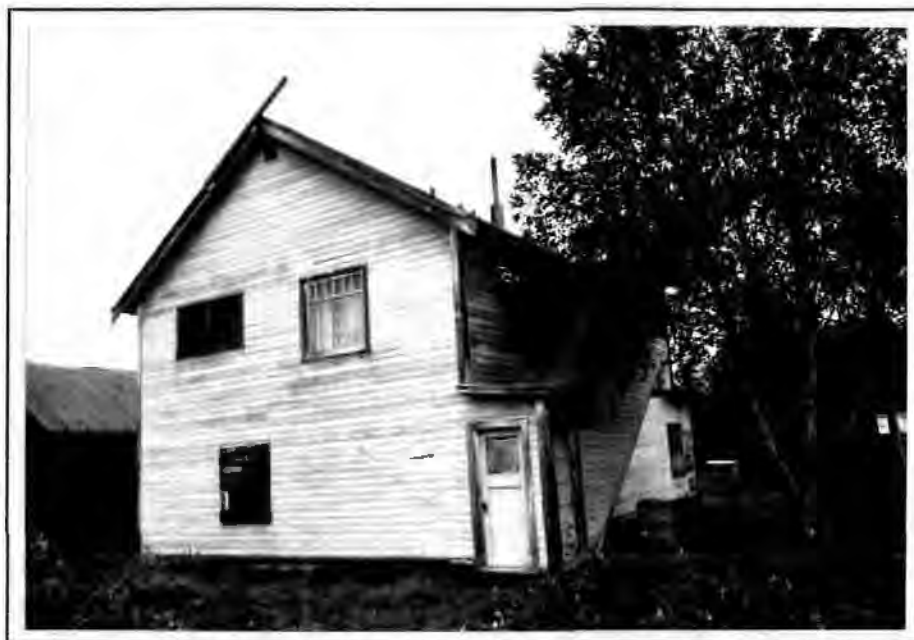
The Donnelley House (IDT-085) is a rectangular, two-story, wood frame building (Figure 43) measuring 26'5"x31'5". The foundation consists of wood blocks. The gable roof is covered with corrugated metal. Shiplap siding with corner boards covers the exterior walls. The main entrance faces west and has a boarded up window centered on the first floor. The second floor has a 1/1 horizontal single-hung window and a seven-light, fixed sash window. The second floor of the south elevation has two single-light, fixed sash windows. An enclosed exterior stairwell with a shed roof extends from the west end of the first floor to the center of the second floor. At

the lower end of the stairway is a single-panel door with one light facing west and a five-panel door facing south. The upper end of the enclosed stairway has a single-light, fixed sash window facing south and east. The ground floor of the north elevation contains a one-panel door with one-light and two single-light, fixed sash windows. The second floor has a 1/1 horizontal single-hung window and a single-light, fixed sash window.

Figure 43. The Donnelley House, 1993.  
The view is looking northeast.

The north end of the east elevation of the house has a two-story gable roof addition measuring 10'2"x12'2". A one-light, fixed sash window is located on the ground floor of the north elevation and a 1/1 double-hung window is located on the second floor of the south elevation. A one-story shed roof addition is located on the south end of the east elevation of the house. The addition measures 10'2"x14'2". The addition has a boarded up window on the south elevation and a one-story, shed roof arctic entry on the east elevation. A five-panel door is centered on the south elevation of the arctic entry. Both additions and the arctic entry have corrugated metal roofs and shiplap siding with corner boards.

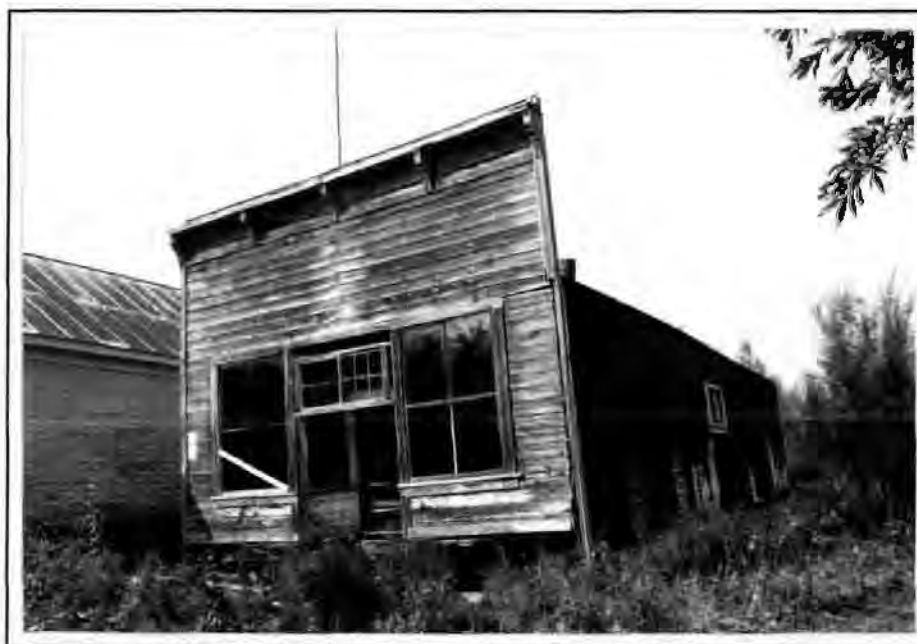
The **Turner and Wood Store (IDT-086)** is a rectangular, 1.5 story, wood frame commercial building (Figure 45). The foundation consists of timbers. The gable roof is covered with corrugated metal and the building measures 24'9"x60'3". Shiplap covers the east elevation. Roofing felt covers the other elevations. The main entrance faces east and has a false front with a recessed entry. The false front has a cornice with five brackets. A large four-light, store front window is located on each side of the recessed entry and a pair of six-light windows is located above the door. The recessed entry has a three light window on each side, a three panel door with one light, and a hopper transom window. The north elevation has a six-light, fixed sash window. The south elevation has a plank door covered with vertical shiplap. The west elevation has a five-panel door with a transom window, a fourteen light, fixed sash window on each side of the door, and a six-light, fixed sash window in the gable.

**Figure 45. The Turner and Wood Store, 1993. The view is looking southwest.**

A wood frame addition measuring 6'2"x10'4" covers the door on the west elevation. This addition has a shed roof covered with corrugated metal. The exterior is covered with roofing felt over shiplap. The north elevation of the west addition has a three light, fixed sash window and the south elevation has a six-light, fixed sash window. The west elevation has a five-panel door and a 3'9"x4'2" shed roof addition. This second addition, which has no exterior doors or windows, has the same exterior siding and roof covering as the west addition.

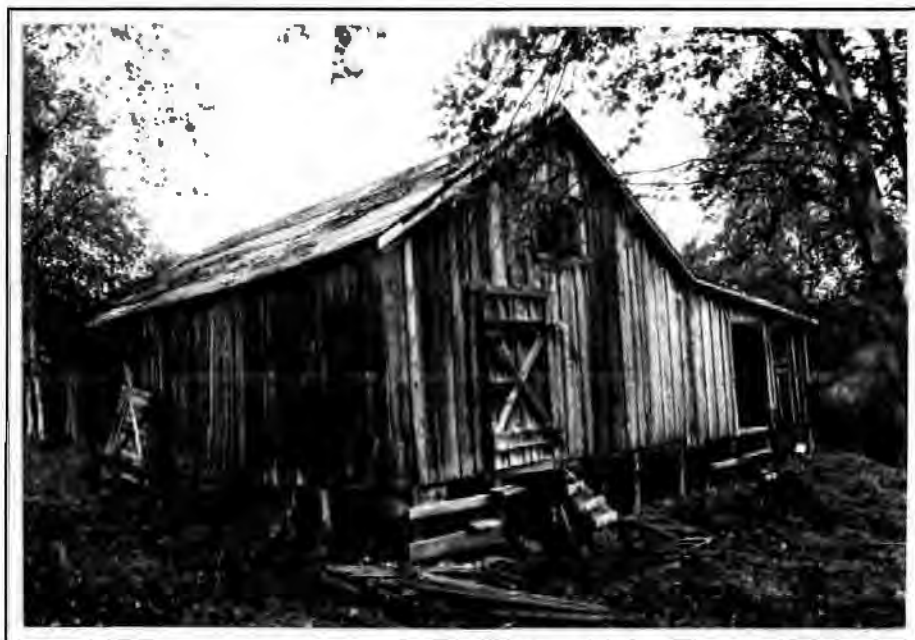
The Turner and Wood Warehouse #1 (IDT-087) is a rectangular, 1.5 story, wood frame building (Figure 46) measuring 18'10"x42'6". The foundation consists of horizontal timbers and wood posts. The gable roof is covered with roofing felt over wood decking. The exterior siding is board and batten partially covered with roofing felt. The main entrance faces east and has a large plank door and a six-light, fixed sash window in the gable. Two pairs of utility doors are located on the west end of the south elevation. The west elevation has a boarded up window at ground level and a boarded up window in the gable.

Figure 46. The Turner and Wood Warehouse #1, 1993. The view is looking northwest.

Warehouse #1 was built in Iditarod, but the date of construction is unknown. Turner and Wood moved the building to Flat in the early 1930s. Turner and Wood used the building to store gasoline and kerosene in case lots and other inventory for their store. Harry Donnelley purchased the building after 1945, but Donnelley did not use the building. In the following years, local residents stored dog sleds in the warehouse (Miscovich 1995:III-46-47).

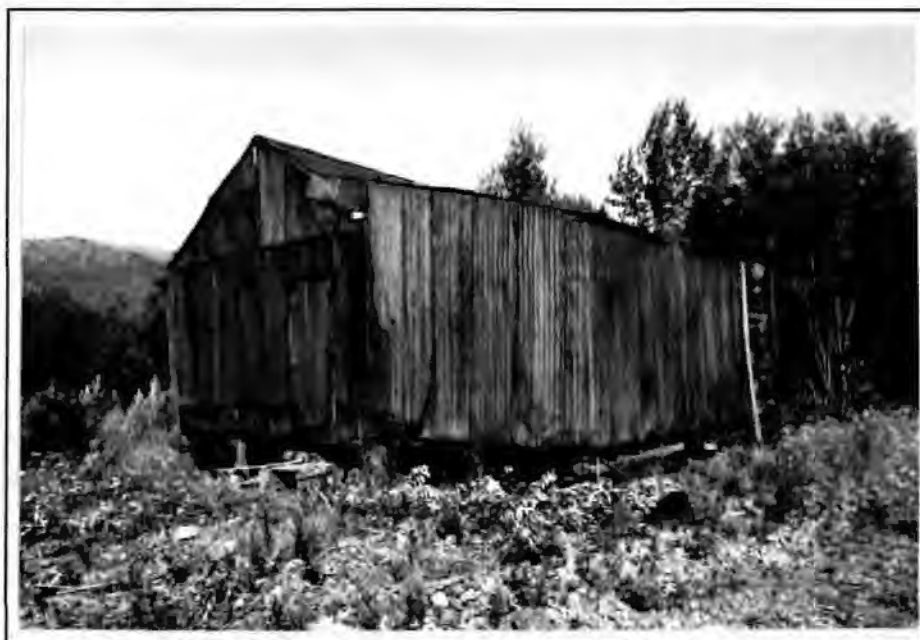
The Turner and Wood Warehouse #2 (IDT-088) is a one-story, rectangular, wood frame building (Figure 47). The foundation consists of stacked wood blocks and logs. The gable roof on the main building, a shed roof addition on the south side, and the exterior walls are covered with corrugated metal. The building measures 16'x24'. The main entrance faces east and features a large utility door which opens onto a 6'x6'6" loading dock. A large plank door covered with corrugated metal is located on the west elevation. The south addition measures 10'x24'. A window opening is located on the east elevation of the addition. The building is in fair condition. Blazo cans, cases of paper bags, aviation fuel, wire, and chains were located in the warehouse in 1993.

Figure 47. The Turner and Wood Warehouse #2, 1993. The view is looking northeast.

George Turner and Ira Wood built warehouse #2 in the late 1920s about the same time they built their store building. Turner and Wood used the building to store inventory, including dog fish and other commodities, for the general store. The building was originally located on the north side of Otter Creek, but it was moved to the south side when Turner moved his store in the late 1930s. Harry Donnelley purchased the building from Turner and Wood after World War II. He used the building as a warehouse and kept furniture in it (Miscovich 1995:I-14-15).

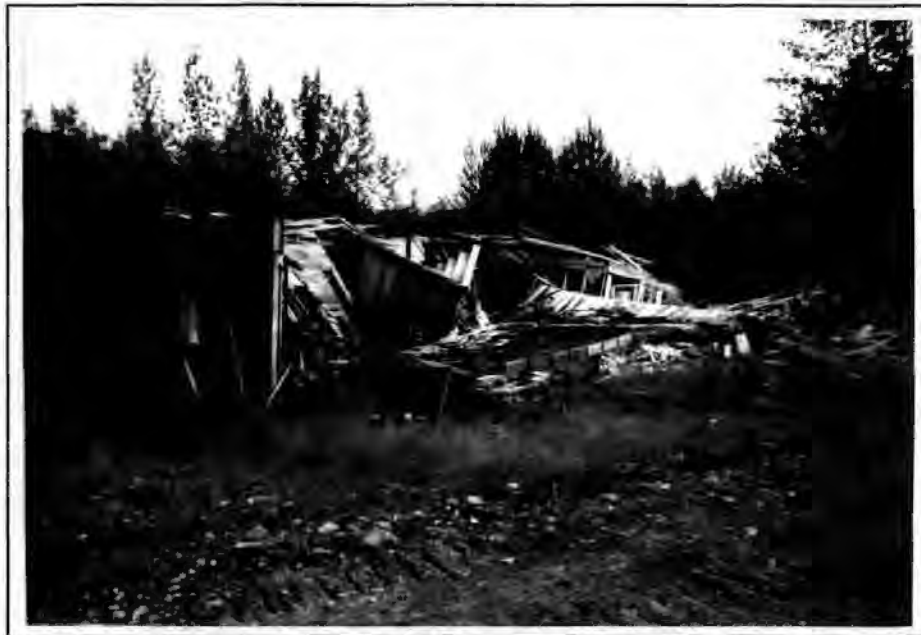
The Adams/Lawrence Hotel and Bar (IDT-089) was a two-story, wood frame, false front building that is in ruins (Figure 48). The foundation was beams on grade. The gable roof was covered with galvanized metal over rolled roofing and wood decking. The exterior siding was covered with shiplap. The main building ruins measures 24'x66'. The main entry faced south, but the south wall has collapsed and is buried in structural debris. The first floor walls on the north elevation and part of the west elevation are still standing. Door and window openings are visible, but the doors and windows are missing. The second floor and roof has collapsed onto the first floor. A collapsed stairway to the second floor is visible in the ruins. The covering on the first floor is linoleum over tongue and groove decking.

The collapsed and scattered ruins of a one-story addition are located on the east side of the hotel. These were the living quarters for the Lawrence family who operated the hotel. A collapsed wood frame addition measuring 11'x20' is attached to 6' of the east end of the south elevation of the hotel. The addition was a wood shed and storage area (Miscovich 1995:II-170). It appears to have been one-story with a shed roof.

**Figure 48. The Adams/Lawrence Hotel, 1993. The view is looking northeast.**

The Adams/Lawrence Hotel and Bar was the third in a succession of hotels. The first hotel, known as the Grand Hotel, was located where the Turner and Wood Warehouse #1 is now. It was destroyed in the 1924 fire. The second hotel was constructed on the site of the original hotel. George Adams bought the second hotel. This was the only hotel in Flat in the years after the 1924 fire. In the late 1920s, the building was cut in half and moved to make way for the Matheson Dredge. The top half of the second hotel became the Adams Dog Barn (IDT-090). George Adams built the third hotel (IDT-089) about 1930, shortly after the second one was cut in half and moved. Adams also operated a still and sold liquor to old timers during Prohibition. Adams left Flat in 1933 or 1934, about the same time that Harry Lawrence came to Flat. George Turner bought the hotel and took Lawrence on as a partner. Lawrence built the bar on the north side of the hotel in the mid-1930s. The bar was a one-story, wood frame addition that ran the length of the hotel and extended 20' to the north. Lawrence also built living quarters on the east side of the hotel for his wife and daughter. Lawrence continued operating the hotel and bar until the summer of 1943 when he suffered a stroke and left Flat. Turner died shortly thereafter and the building was abandoned. In 1966, Alvin and Sergie Agoff bought the partially collapsed building from Turner's sons. The Agoffs and other residents of Flat tore down the bar addition and have salvaged lumber from the hotel ruins. (Miscovich 1995:I-14-15; II-16-17; Agoff 1995:222-223).

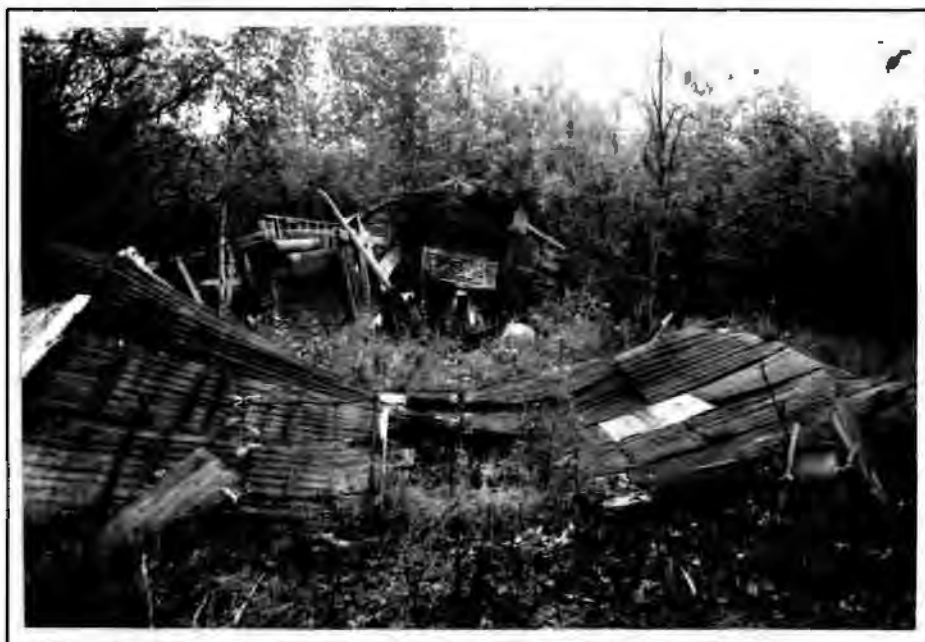
The Adams Dog Barn (IDT-090) is the ruins of a collapsed rectangular, one-story, wood frame building (Figure 49). The foundation was on grade. The gable roof and shed roof additions were covered with corrugated metal. The building measures 14'x41' and is oriented north-south. Corrugated metal covered the exterior walls. Only the north elevation and part of

the west elevation are standing. The north elevation has a door opening. Dog stalls measuring 1'9"x 3'8" are located in the interior of the west elevation. The south elevation, which has collapsed into the building, had a door opening. The south gable measured 11'6". A shed addition on the west side of the building measures 8'x41'. The north wall, which is still standing, has an awning window. The west elevation of the addition is partially

**Figure 49. The ruins of the Adams Dog Barn. 1993. The view is looking north.**

standing and has dog stalls lining the north end of the interior wall. These stalls measure 2'6"x4'. The south elevation has a plank door. A shed addition on the east side of the building measures 12'x41'. All of the walls of this addition have collapsed. The east elevation has a window opening and there was a plank door on the south elevation.

The main portion of the Adams Dog Barn was the bottom half of the Grand Hotel (Kepler 1995:130). George Adams moved the lower half of the old hotel in the late 1920s and converted it to a dog barn to shelter sled dogs for mail carriers who stopped in Flat. Airplanes began delivering mail to Flat in 1925 and airmail cut into the work of dog mushers who carried the mail. By 1927 or 1928, airmail replaced the winter delivery of mail by dog sled and Adams abandoned the building in the 1930s. The building was still standing in the 1950s. After the roof collapsed, local residents salvaged lumber and corrugated metal from the building (Miscovich 1995:II-18).

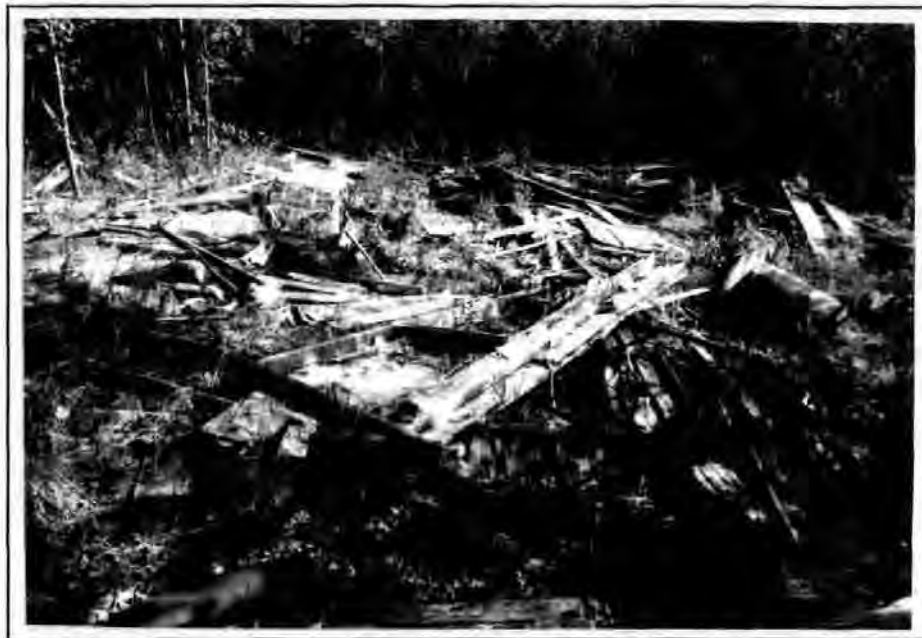
**ACS Wireless Station Site (IDT-091)** consists of the foundation and ruins of a rectangular, one-story, wood frame building (Figure 50). Most of the roof and walls have been salvaged. The foundation consists of wood blocks. A section of the collapsed roof in the northeast corner of the ruins consists of rolled roofing over wood decking. The ruins of the building measure 24'x40'. Collapsed wall sections are located on the north and west sides of the site. The exterior was covered with rolled roofing over horizontal wood siding. A door frame, flanked by two window openings, is located in the remains of the north elevation. A window frame is located in a section of the west wall that is laying outside the building. Interior artifacts include a metal sink, metal bedposts, stove pipe, a section of interior wall with a door frame, and a concrete generator stand.

**Figure 50. Ruins of the ACS Wireless Station near Otter Creek, 1993. The view is looking north.**

The date this building was constructed is unknown, but it probably was built in the 1920s. The building served as the Alaska Communications System Wireless Station in Flat during the early and mid-1930s. The building was too cold to maintain, so the ACS operator, Jim Ellison, moved the station to Harry Donnelley's old house on Flat Creek Road in 1937 after Donnelley built a new house. The building was abandoned in the 1940s and 1950s. The roof had collapsed by 1966 when Minnie Brink tore the building down and salvaged the lumber (Agoff 1995:223).

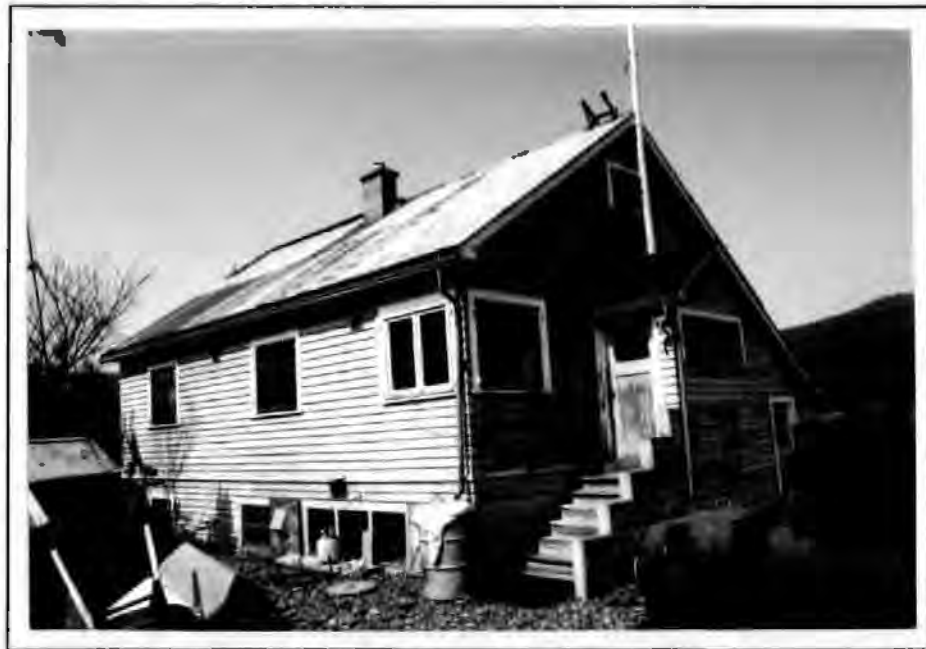
The **Matheson House (IDT-102)** is a rectangular, 1.5 story, wood frame residence (Figure 52). The foundation is concrete and includes a full basement. The gable roof is covered with corrugated metal. A roof dormer with a shed roof and a triple six-light, fixed sash window faces north. The building measures 25'x34'6". Clapboard covers the exterior walls. The main entry is the north elevation, which has two six-light, fixed sash windows. A gable roof arctic entry measuring 6'x8'8" is located on the east end of the north elevation. The arctic entry has a pair of six-light, fixed sash windows facing north and a six-light window facing east. A single-panel door with one-light faces west, but the exterior stairway to the door is missing. The west elevation has a six-light, fixed sash window on the ground floor and a six-light, fixed sash window under the gable. The south elevation has two six-light, fixed sash windows and a pair of single-light, casement windows. The east elevation has two six-light, fixed sash windows on the ground floor, a six-light, fixed sash window in the gable, and an arctic entry with a gable roof. The arctic entry measures 4'x14', has a pair of six-light, fixed sash windows facing east, and a single-panel door with one-light that accesses the basement. Stairs rise to a single-panel door with one-light that faces south. The basement has two six-light, fixed sash windows facing north and two six-light, fixed and four two-light, fixed sash windows facing south. Decorative features on the house include enclosed cornices with small returns, matching storm windows on many of the windows, a stair stepped wall adjacent to the steps leading up to the door of the east arctic entry. The house also has gutters and downspouts.

Figure 52. The Matheson House, 1993.  
The view is looking northwest.

A 10'2"x10'2" metal tower approximately 50' tall is located 5'2" southwest of the house. A Jacob Electric Windmill is located on top of the tower. A wood frame greenhouse measuring 15'5"x10'10" is located 6'10" south of the house. The roof and sides of the greenhouse are covered with multi-light windows. A large garden area measuring 57'x112' is located 5' south of the greenhouse. The garden is surrounded on the north, east and west sides by a rock wall that varies in height from 3' to 4'6".

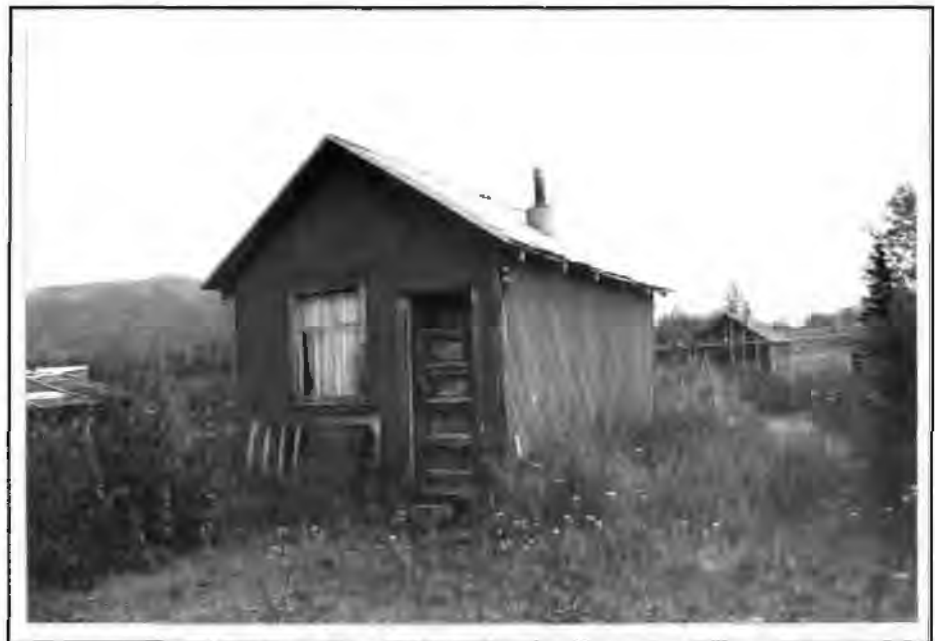
The **Matheson Guesthouse (IDT-103)** is a one-story, wood frame building (Figure 53) located 18'6" east of the Matheson rock garden. The foundation of the guesthouse consists of logs on grade. The gable roof is covered with corrugated metal. The guesthouse measures 12'5"x16'2". The exterior walls are covered with green asphalt roofing felt and have corner boards. The main entry is on the north elevation, which has a five-panel door and a four-light window. A screened window frame with no glass is centered on the south elevation.

**Figure 53. The Matheson Guesthouse, 1993.**  
The view is looking southeast.

The date and location where the guesthouse was built are unknown. John Stevens moved the house to its present location sometime after 1960. Stevens built the two wood sheds after he purchased the Matheson property in 1960. He used them to store fire wood for the furnace in the Matheson House (Mischovich 1995: III-33).

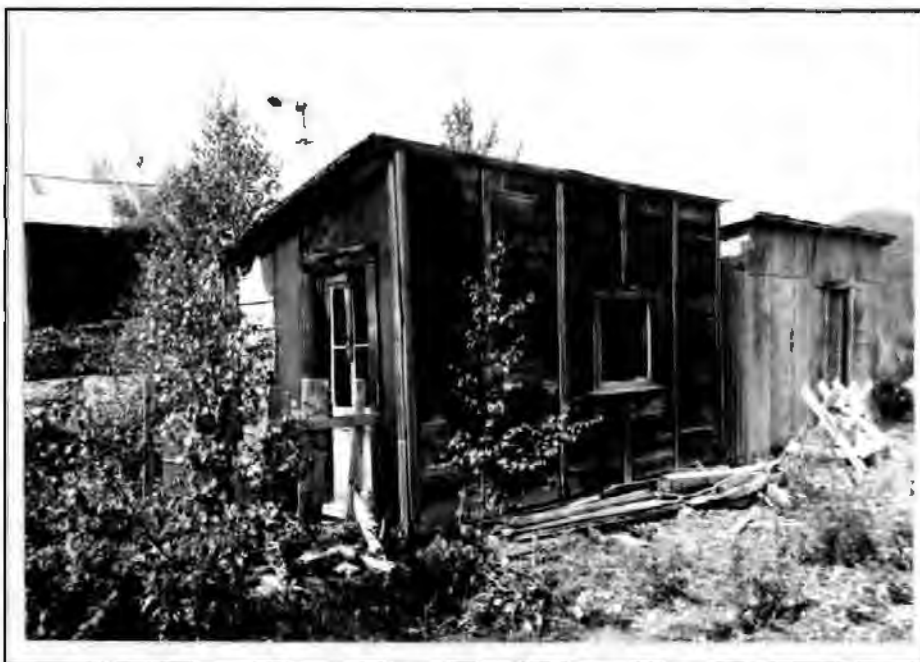
Two small rectangular, one-story, wood frame buildings (Figure 54) are located 30' east of the Guesthouse. The northern most of the two buildings is Wood Shed #1. It measures 10'4"x14'2" and the

foundation is on grade. The siding and shed roof are covered with corrugated metal. A plank door covered with corrugated metal faces east. Wood Shed #2 measures 10'4"x14'2" and the

foundation is on grade. The exterior siding and shed roof are covered with roofing felt over wood siding, but weathering has stripped away most of the roofing felt. The east elevation has a single-light, fixed sash window. A four-panel door is located on the north elevation and a two-panel door with four lights is located on the south elevation. A boarded up window is located on the west elevation.

Figure 54. The Matheson Wood Sheds, 1993. The view is looking northwest.

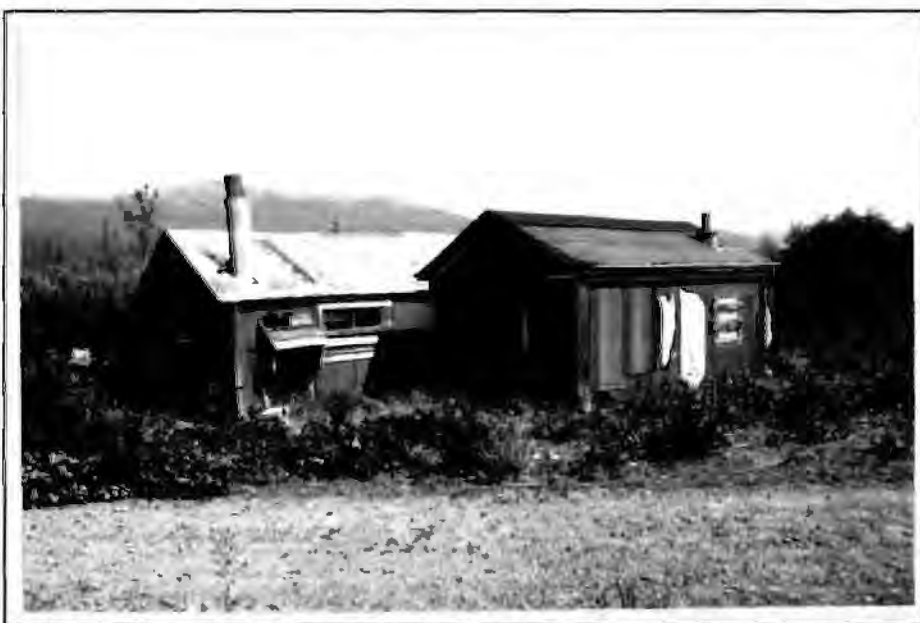
The Matheson Mess Hall (IDT-104) is a rectangular, one-story, wood frame building (Figure 55) with two additions. The foundation consists of logs. The gable roof is covered with corrugated metal and is oriented east-west. The building measures 18'3"x 26'5". Asphalt rolled roofing covers the ex-

Figure 55. The Matheson Mess Hall (left) and Cook's Quarters (right), 1993. The view is looking northeast.

terior walls. The main entry is on the south elevation, which contains a 1/1 horizontal double-hung window and a five-panel door. The west elevation has a 1/1 horizontal double-hung window. The east elevation has a three-panel door, a 6/6 horizontal double-hung window, and a six-light, fixed sash window.

The cook's quarters is a rectangular, one-story, wood frame building located 4'2" south of the mess hall. The foundation is horizontal timbers on grade. Corrugated metal and roofing felt cover the gable roof, which is oriented east-west. The building measures 12'4"x18'4" and the exterior walls are covered with roofing felt. A two-panel door faces north and is covered by a corrugated metal porch which links the building to the Mess Hall entry. A single-light, fixed sash window is also located on the north elevation. A 1/1 horizontal single-hung window is located on the west elevation and a boarded up window is located on the south elevation. A shed roof addition located on the east end of the structure measures 8'2"x8'3". The roof and exterior walls are covered with roofing felt over wood siding.

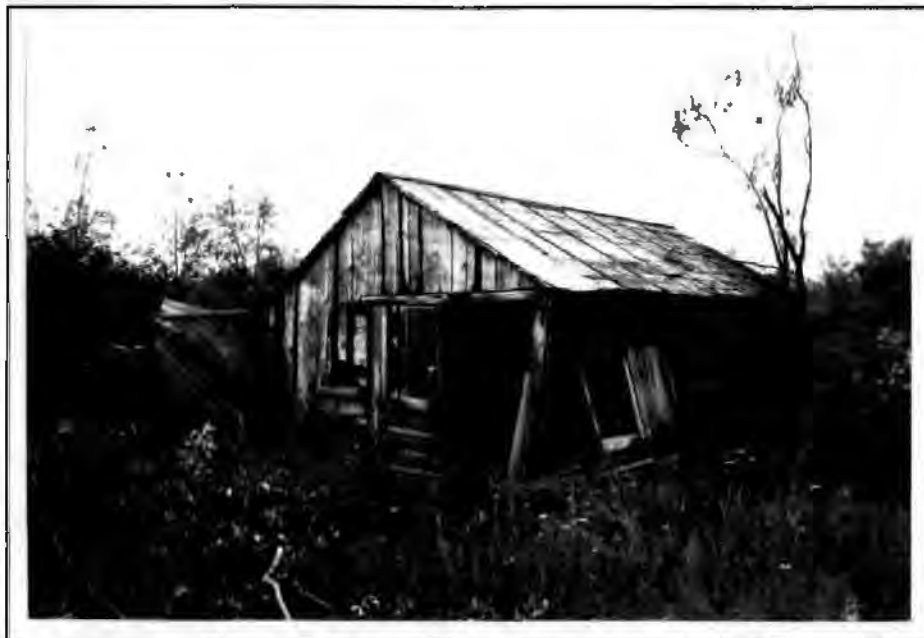
**The Matheson Storage Building (IDT-105)** is a rectangular, one-story, wood frame building (Figure 56) with an addition. The foundation consists of logs. The gable roof has corrugated metal on one-side and weathered roofing felt over wood decking on the other. The building measures 15'x23'11". The exterior is covered with roofing felt over vertical wood siding and features corner boards. The main entrance is on the east elevation, which features a pair of large plank doors, although one of the doors is missing. A boarded up window is located on the north elevation. A boarded up six-light, fixed sash window and a boarded up personnel door are located on the west elevation.

An addition with a collapsed shed roof is on the west side of the building. The addition measures 12'2"x23'11". The shed roof is covered with corrugated metal over roofing felt and the exterior is covered with roofing felt over horizontal wood siding. A single-light, fixed sash window is located on the west elevation. The south elevation has a two-light, fixed sash window. A belt driven table saw and extra glass windows were stored in the building in 1993.

Figure 56. The Matheson Storage Building, 1993. The view is looking southwest.

The date the Matheson Storage Building was constructed is not known, but it likely dates to the late 1920s or early 1930s. Alex and Marie Matheson kept a car in the building for many years (Mischovich 1995:III-35).

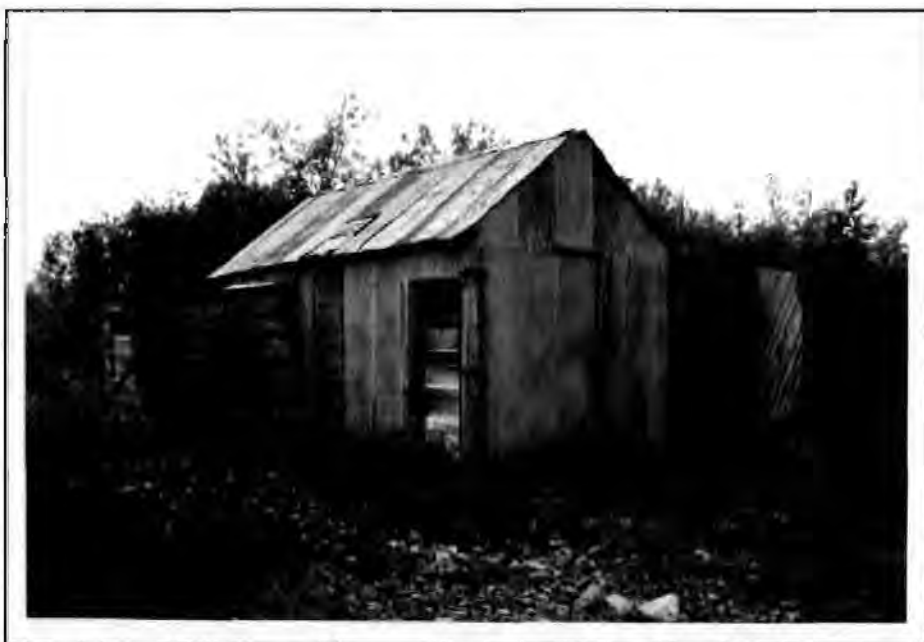
The Matheson Garage (IDT-106) is a rectangular, one-story, wood frame building (Figure 57) with two additions. The foundation consists of wood blocks. The gable roof and exterior walls are covered with corrugated metal.

The garage measures 12'x18'8". A pair of side opening utility doors are centered on the north elevation. A shed addition measuring 8'8"x12'2" is located on the west side of the building.

Corrugated metal covers the shed roof. The exterior walls are covered with shiplap. A pair of side opening utility doors are centered on the north elevation of this addition. A four-panel door with one light is located at the north end of the east elevation. At the south end of the east elevation is a small 6'x6' shed addition. Corrugated metal covers the shed roof. The exterior walls are

Figure 57. The Matheson Garage, 1993. The view is looking southwest.

covered with shiplap. A small 3'3"x8' shed addition is centered on the south elevation of the garage. Corrugated metal covers the shed roof and the exterior walls are covered with horizontal siding.

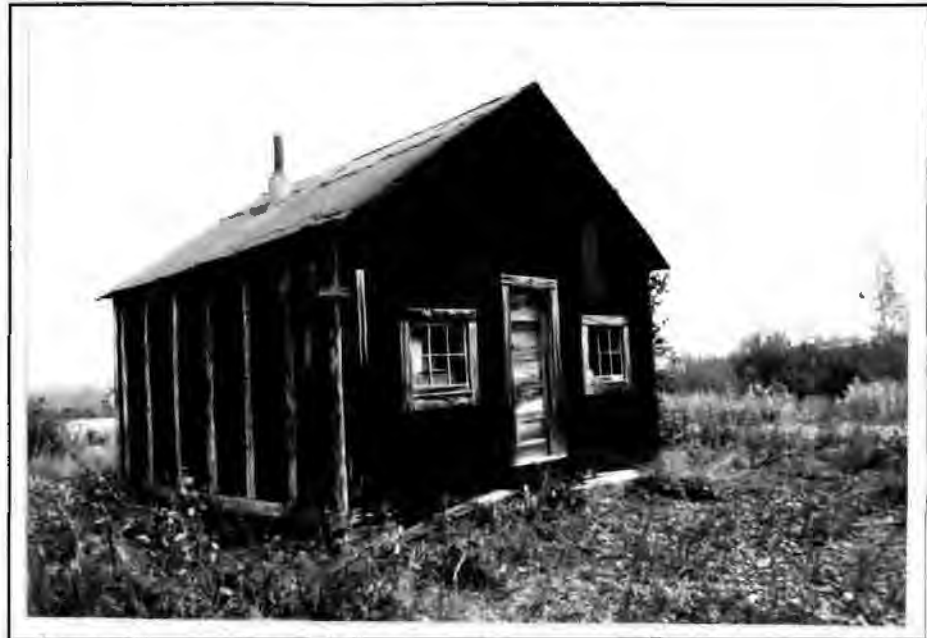
The **Byrd/Stevens Garage (IDT-107)** is a rectangular, one-story, wood frame building (Figure 58) located 17' east of Matheson Garage #1. The foundation of Garage #2 consists of wood blocks. Corrugated metal covers the gable roof. The building measures 18'3"x18'4" and the exterior walls are covered with roofing felt and batten. A five-panel door is centered on the south elevation and is flanked on each side

**Figure 58. The Byrd/Stevens Garage, 1993.**  
The view is looking northeast.

by a six-light, fixed sash window. A pair of side opening utility doors is located on the north elevation.

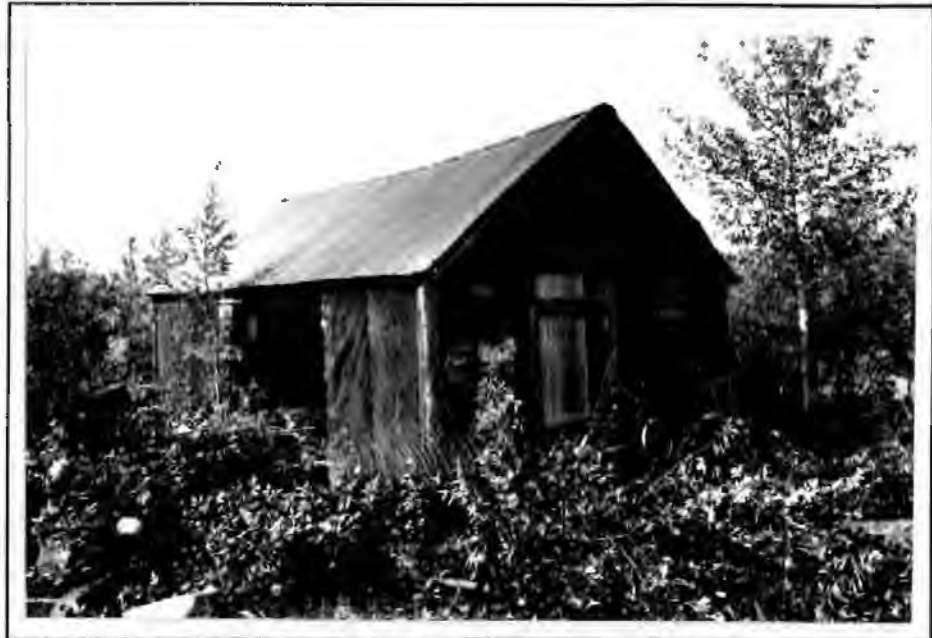
The **NADC Parts Warehouse (IDT-108)** is a rectangular, one-story, wood frame building (Figure 59). The foundation consists of timbers on grade. The gable roof is covered with corrugated metal. The building measures 16'5"x24'5". Roofing felt over horizontal siding covers the exterior walls. The main entry is on the east elevation, which features a vertical plank door covered with corrugated metal. A two-light, fixed sash window is located on the south elevation. The building is in fair condition. A small animal cage is located just outside the north wall of the building. A large pipe wagon in good condition is located 20' north of the building.

The NADC Parts Warehouse dates to the late 1920s or early 1930s. It is associated with Alex Matheson's North American Dredging Company. The warehouse contained dredge parts during 1993 (Agoff 1995: 236; Miscovich 1995: III-34).

**Figure 59. The NADC Parts Warehouse, 1993. The view is looking northwest.**

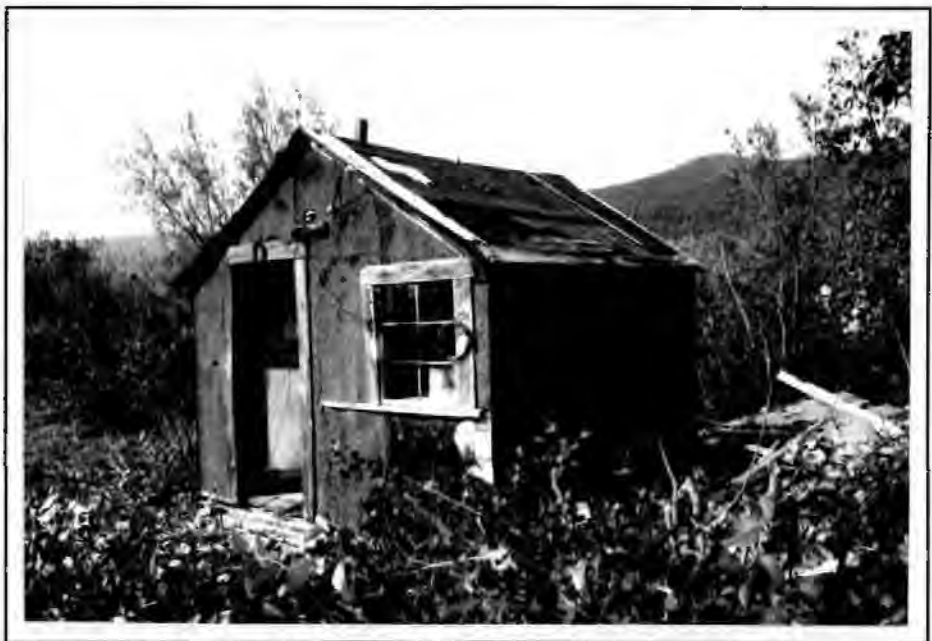
The NADC Washroom (IDT-109) is a rectangular, one-story, wood frame building (Figure 60). The foundation consists of timbers on grade. Roofing felt covers the gable roof. The building measures 10'4"x12'2" and the exterior walls are covered with roofing felt. The main entry is on the south elevation, which has a five-panel door and a six-light, fixed sash window. A boarded up window is located on the west end of the north elevation.

**Figure 60. The NADC Washroom, 1993. The view is looking northwest.**

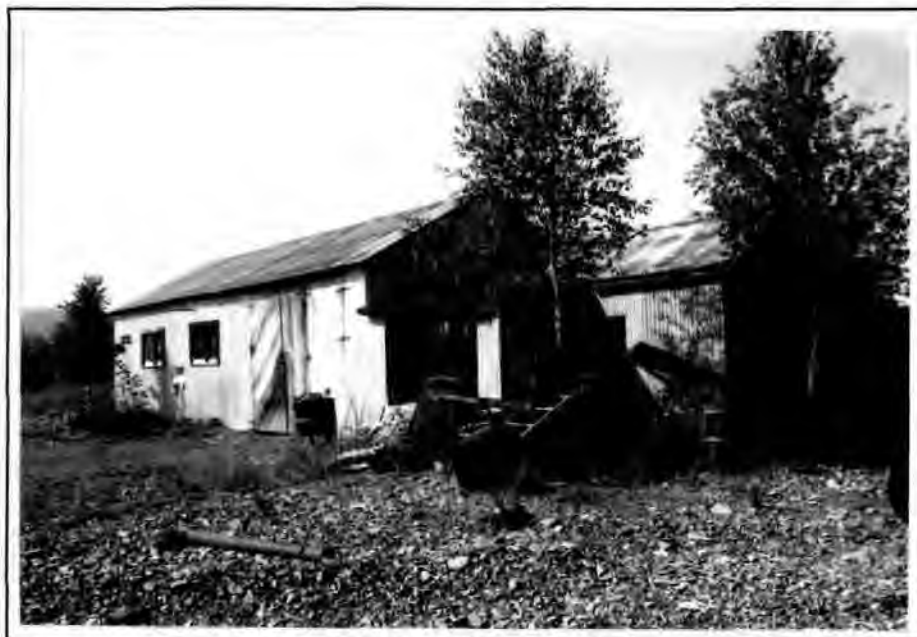
The **NADC Machine Shop (IDT-110)** is a rectangular, one-story, wood frame building (Figure 61). The foundation is on grade. Corrugated metal covers the gable roof and exterior walls. The machine shop measures 20'x40'. The main entry is on the south elevation, which features a pair of large side-opening doors and two 4/4 horizontal single-hung windows. Two 4/4 horizontal single-hung windows are located on the north elevation. The west elevation has a 4/4 horizontal single-hung window and a large plank door. A 6'x10'4" shed addition is located on south end

of the east elevation. The addition has a pair of side opening doors facing south. A gable roof addition is attached to the north end of the machine shop. The addition measures 14'x18'3". The roofs and exterior of these two additions are covered with corrugated metal. The north and south elevations of the gable addition have a six-light, fixed sash window. The east elevation has a small plank door. The power tools inside the shop are the original belt driven tools and they are in good condition.

**Figure 61. The NADC Machine Shop, 1993.**  
The view is looking northwest.

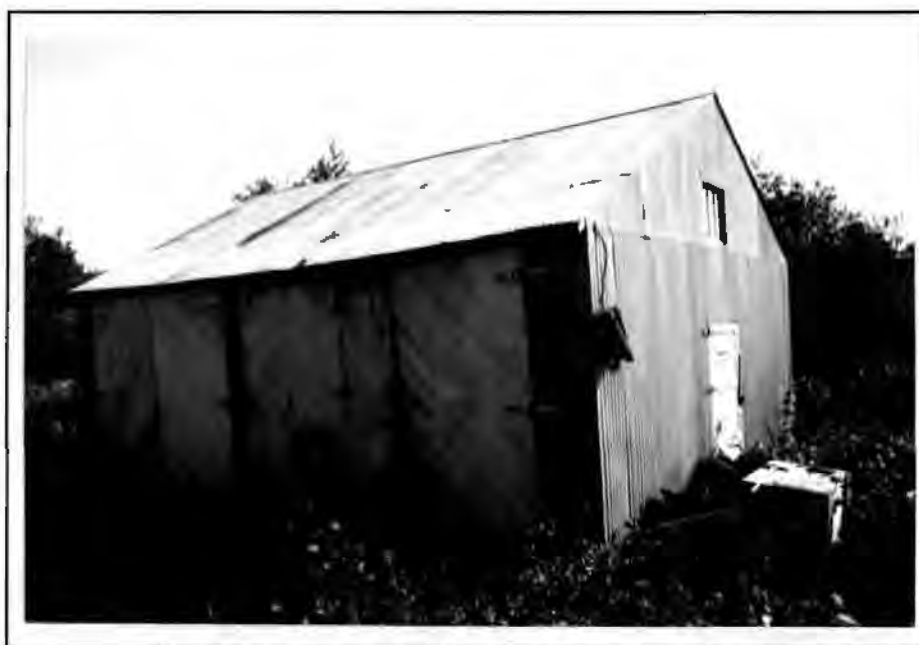
The NADC Garage (IDT-111) is a rectangular, one-story, wood frame building (Figure 62). The foundation is on grade. The gable roof and exterior walls are covered with corrugated metal. Two six-light, fixed sash skylights are evenly spaced on the south slope of the roof. The building measures 24'x29'3". The main entry is on the north elevation, which has two pairs of side opening utility doors. A five-panel door is centered on the west elevation and a six-light, fixed sash window is centered in the gable. Two six-light, fixed sash windows are evenly spaced on the south elevation.

The NADC Garage was a part of Alex Matheson's mining operation. Matheson bought a D-8 Caterpillar Tractor in 1945 and he built the garage in 1946 or 1947 to shelter and maintain the D-8 and other heavy equipment (Agoff 1995:236; Miscovich 1995:III-34).

Figure 62. The NADC Garage, 1993.  
The view is looking southeast.

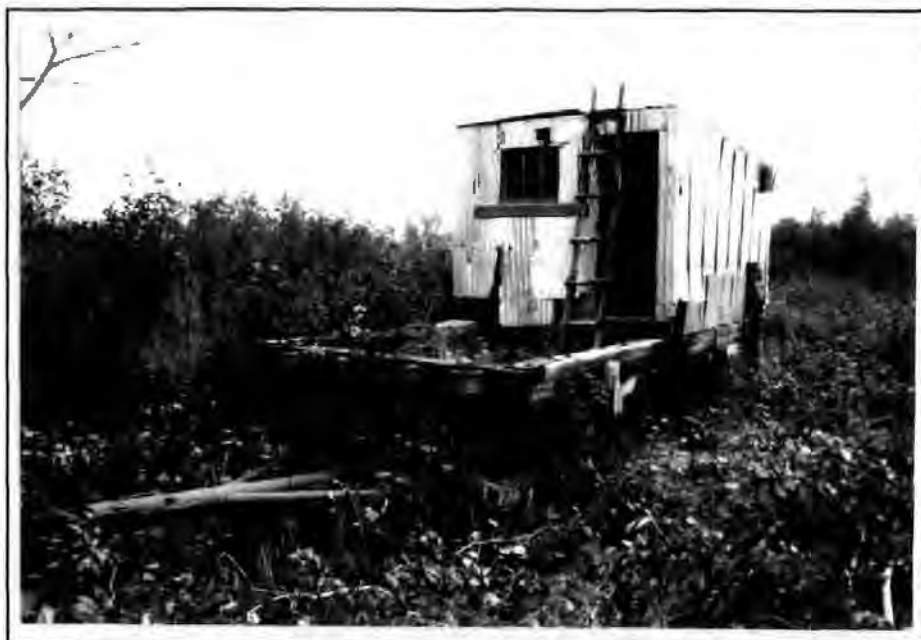
The NADC Wanigan (IDT-112) is a wood frame freight sled measuring 8'2" x 24'5" (Figure 63). The frame and floor are made of heavy timbers braced with metal plates. The tow bar is made of heavy metal pipe. A small rectangular, one-story, wood frame bunkhouse measuring 8'2" x 16', is located on the hack two-thirds of the sled. Corrugated metal covers the flat roof and exterior walls. A plank door and six-light, fixed sash window are located on the front (north) elevation of the bunkhouse. A four-light, fixed sash window is centered on the south elevation. A table, coffee pot, and bunks are located inside the structure. The sled is a

Figure 63. The NADC Wanigan, 1993.  
The view is looking southeast.

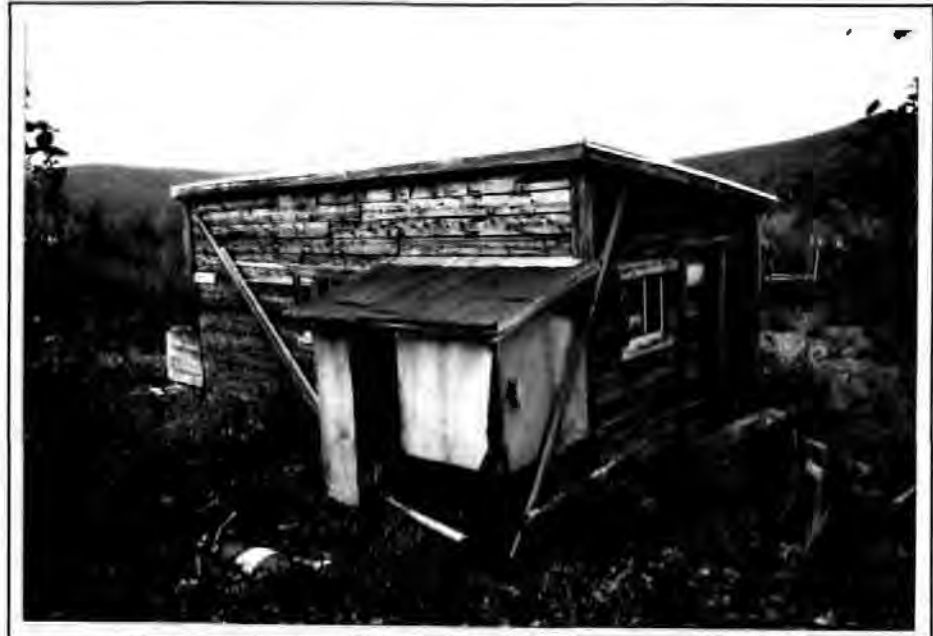
The **Balange Carpentry Shop (IDT-113)** is a rectangular, one-story, wood frame building (Figure 64). The foundation consists of three parallel beams (one along each side and one in the center) which serve as skids during towing. A tow cable is threaded through each of the three skids. Corrugated metal covers the shed roof. The building measures 12'2"x28'10". The exterior walls are covered with horizontal wood siding and corner boards. The north and south walls have diagonal bracing to give the building additional strength. The main entry is on the east elevation, which contains a five-panel door and a two-light, fixed sash window. A pair of fixed sash windows, one with two lights and the other with six lights, is centered on the south elevation. A small 4'x8' shed roof addition with celotex siding is located on the east end of the south elevation. The roof is covered with corrugated metal and a plank door faces west. A row of four storage boxes is located along the base of the west elevation. The boxes, which contained metal parts and fittings, are made of lumber. A shed roof covered with corrugated metal covers the boxes. The building held a set of carpentry tools in 1993.

**Figure 64. The Balange Carpentry Shop, 1993. The view is looking southeast.**

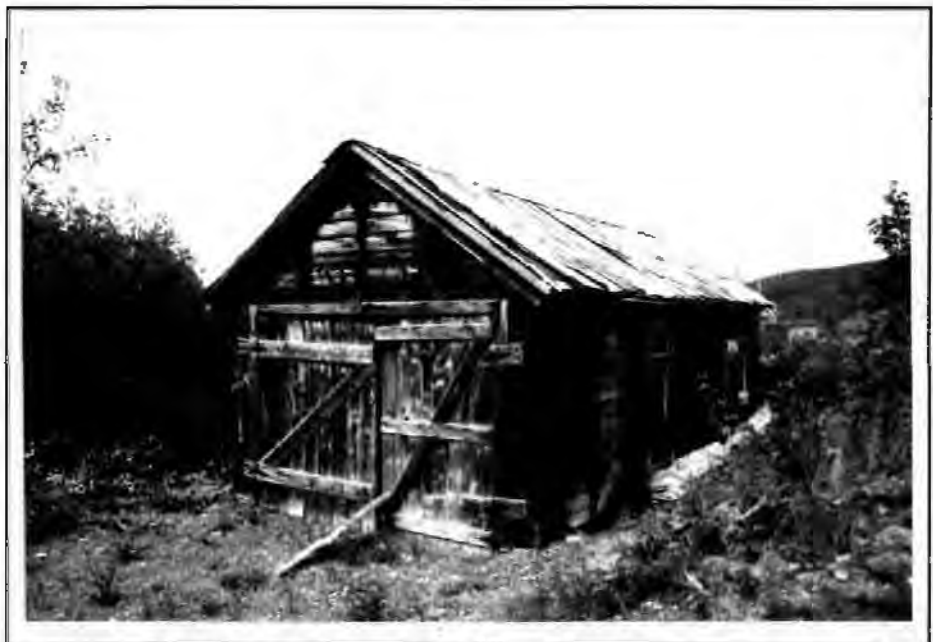
The **Applebaum House/Stevens Garage (IDT-114)** is a rectangular, one-story, wood frame building (Figure 65). The foundation is on grade. The gable roof is covered with corrugated metal. The cullied (double) roof has 1"x1" sleepers between the decking. This is the only cullied roof observed in Flat and one of only a handful of buildings (all residential) that have rain gutters. The

**Figure 65. The Applebaum House/Stevens Garage, 1993. The view is looking northwest.**

building measures 14'x30' and the exterior is covered with roofing felt over wood siding. The walls have been cut off at the base and there are no sill plates. The main entry is on the south elevation, which features a pair of large side-opening plank doors. A plank door is centered on the north elevation. The east elevation has a 2/1 single-hung window and a 1/1 double-hung window. The west elevation has a 1/1 double-hung window and a single-light, fixed sash window. Small strips of three layers of decorative wall paper are located inside the building near the ceiling. Stove pipe is located in the north end of the west slope of the roof. A 1935 model T-40 International Harvester Tractor is parked inside the structure and appears to be in good condition.

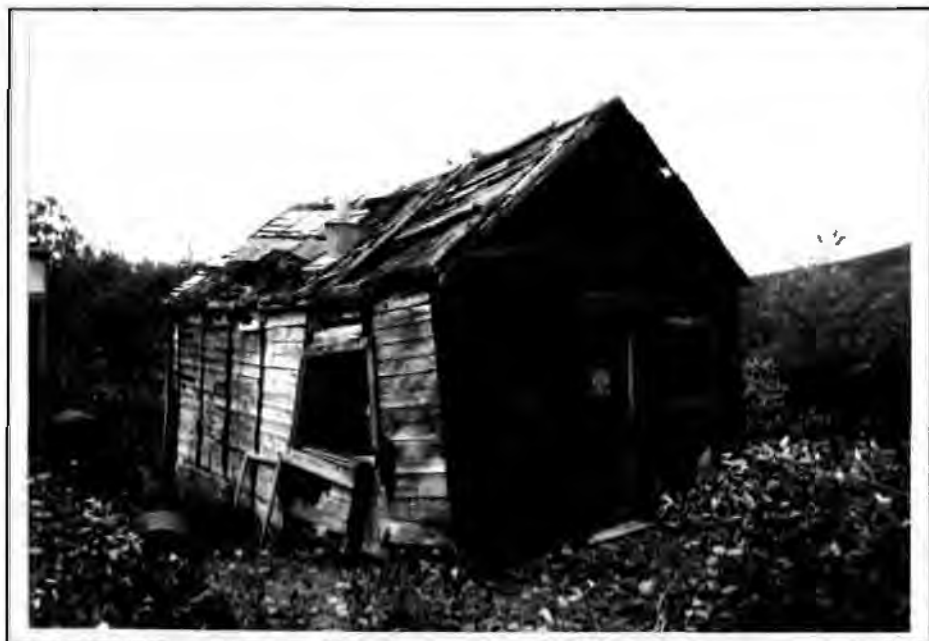
The Joe Mitchell Cabin (IDT-115) is a rectangular, one-story, wood frame building (Figure 66). The foundation is on grade and weathered tar paper covers the gable roof. The building measures 14'4"x18'. The exterior walls are covered with rolled roofing over shiplap. The main entrance faces east and has a three-panel door with a one-light door and a boarded up window. A two-light, fixed sash window is located on the north elevation. A five-panel door is located on the west elevation and a window opening is located on the south elevation.

Figure 66. The Joe Mitchell Cabin, 1993.  
The view is looking northwest.
